# SNOW RETENTION -

# The Invisible Code

By Terry E. Anderson

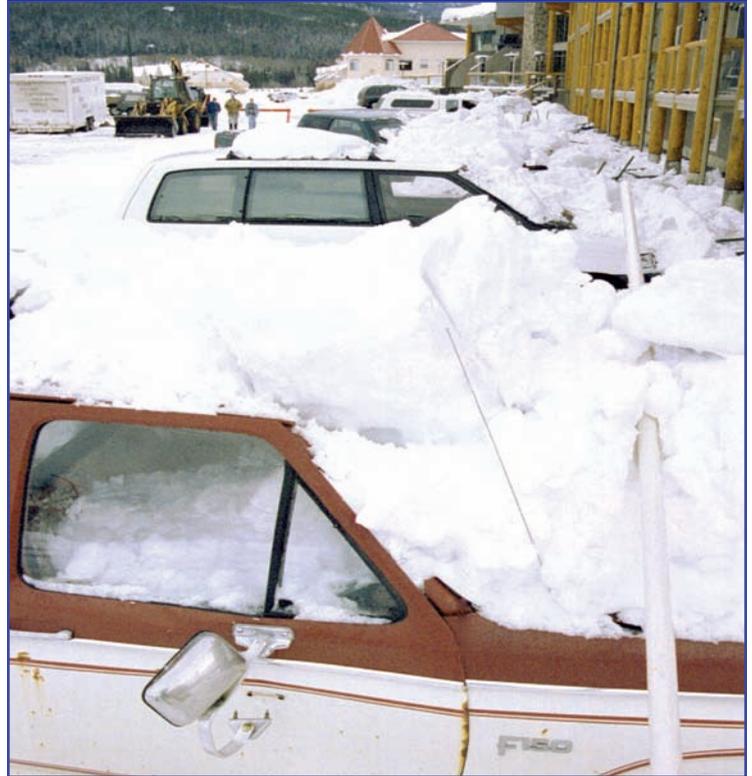
*Photo 4 – A snow retention code needs to be put in place to help prevent injury to people and damage to property.*

There are many other codes in place to protect people and property, so why not for snow retention? We have codes for wind uplift and ICC test standards for product failures due to wind and moisture penetrations, to name a few. How many life-threatening events (*Photo 4*) need to occur before we do the right thing when it comes to a code for snow retention on roofs?
