# SNOW RETENTION -

# The Invisible Code

By Terry E. Anderson

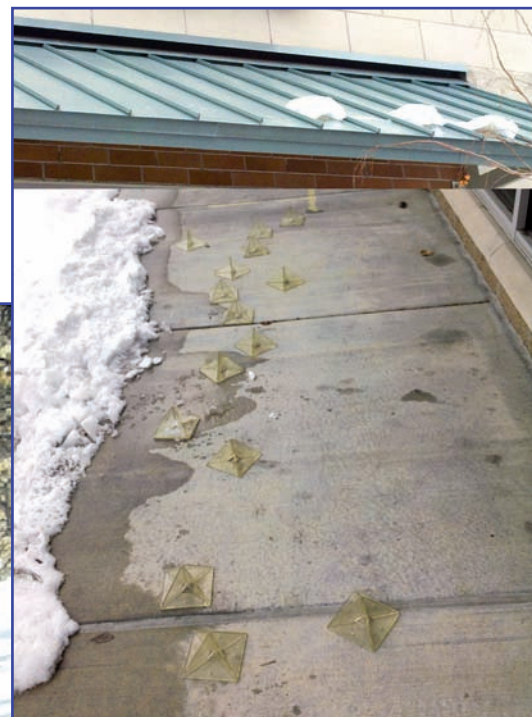
*Photo 1 – Sliding snow can be incredibly dangerous.*

**S**now retention codes do not seem to be a priority within the United States roofing industry. But it is very common to see snow and ice sliding off of a metal roof's slippery surface; crushing cars; and damaging roofs, gutters, and landscapes. In some cases, snow and ice cascading off roofs have killed people. Codes for snow retention systems are essential in order to protect people and property from sliding ice and snow (*Photo 1*).
